CONCLUSIONS

Our studies have shown there is no sign of usage, little to no debris on the new Medtronic Octopus 3[®] or the Medtronic Octopus 4[®] head region when observed by light and scanning electron microscopes and DNA analysis. The debris present appeared to be microscopic, non-organic and typical of the manufacturing process.

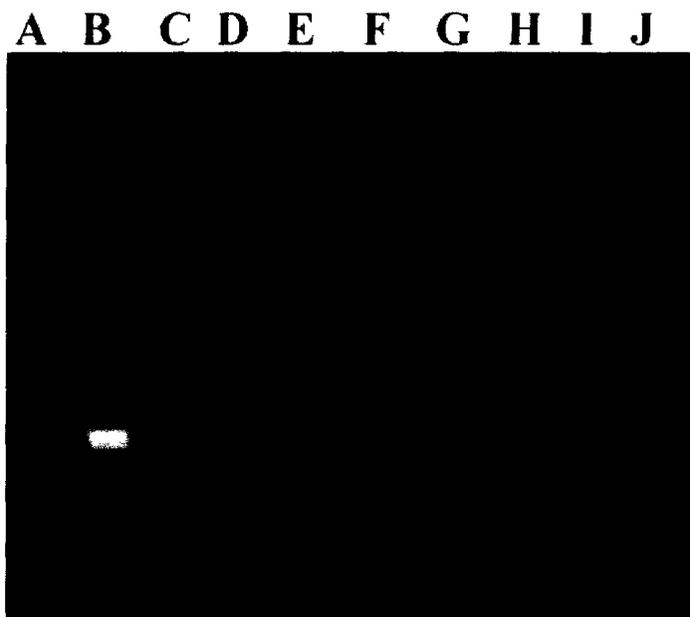
Figure 96. Gel electrophoresis of PCR products. Samples were prepared using the methods listed. Swabs were used to collect samples from individual pods from the new Medtronic Octopus 3[®] MT-104-1 and the reprocessed Medtronic Octopus 3[®] MT-104-3. DNA was extracted using the DNeasy DNA Extraction Kit, a single-copy 536 bp human β -globin fragment was amplified from each sample using standard PCR protocols, and the products were electrophoresed on a 10% polyacrlamide/TBE gel and stained with ethidium bromide (Molecular Probes). A) negative control, no PCR template, B) positive PCR control of 1 ng human genomic DNA template; C-F from new Medtronic Octopus 3[®], C) pod 1, D) pod 3, E) pod 5, F) pod 7; G-J from reprocessed Medtronic Octopus 3[®], G) pod 7, H) pod 5, I) pod 3, J) pod 1. **Pods 5 and 7 of the reprocessed Medtronic Octopus 3[®] are positive for human β -globin fragment.**

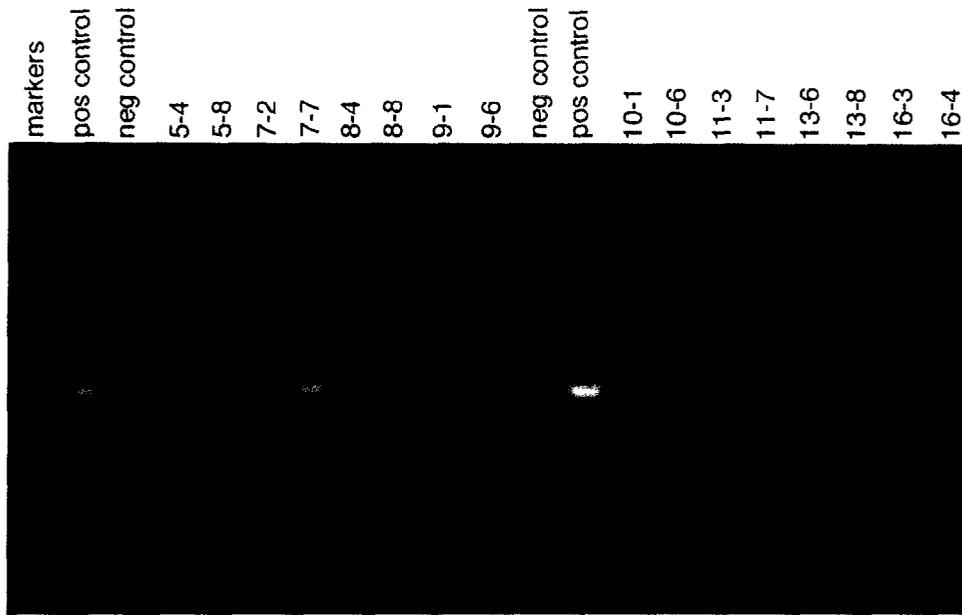
Figure 97. Samples were prepared using the methods listed. Swabs were used to collect material from two individual pods from each of the reprocessed devices. DNA was extracted using the Qiagen DNeasy[®] DNA Extraction Kit, a single-copy 536 bp human β -globin fragment was amplified from each sample using standard PCR protocols, and the products were electrophoresed on a 10% polyacrlamide/TBE gel and stained with ethidium bromide (Molecular Probes). Lanes are labeled as to contents. In numbered lanes, the first label number refers to the device ID and the second is the pod number (i.e. 5-4 is from MT-104-5, pod #4). Positive controls are PCR products of 1 ng human genomic DNA template; negative controls contain no PCR template. **Devices MT-104-7 and MT-104-9 are positive for human β -globin fragment.** Low intensity of the bands is likely due to the condition of the DNA and the small sample size (>1ng).

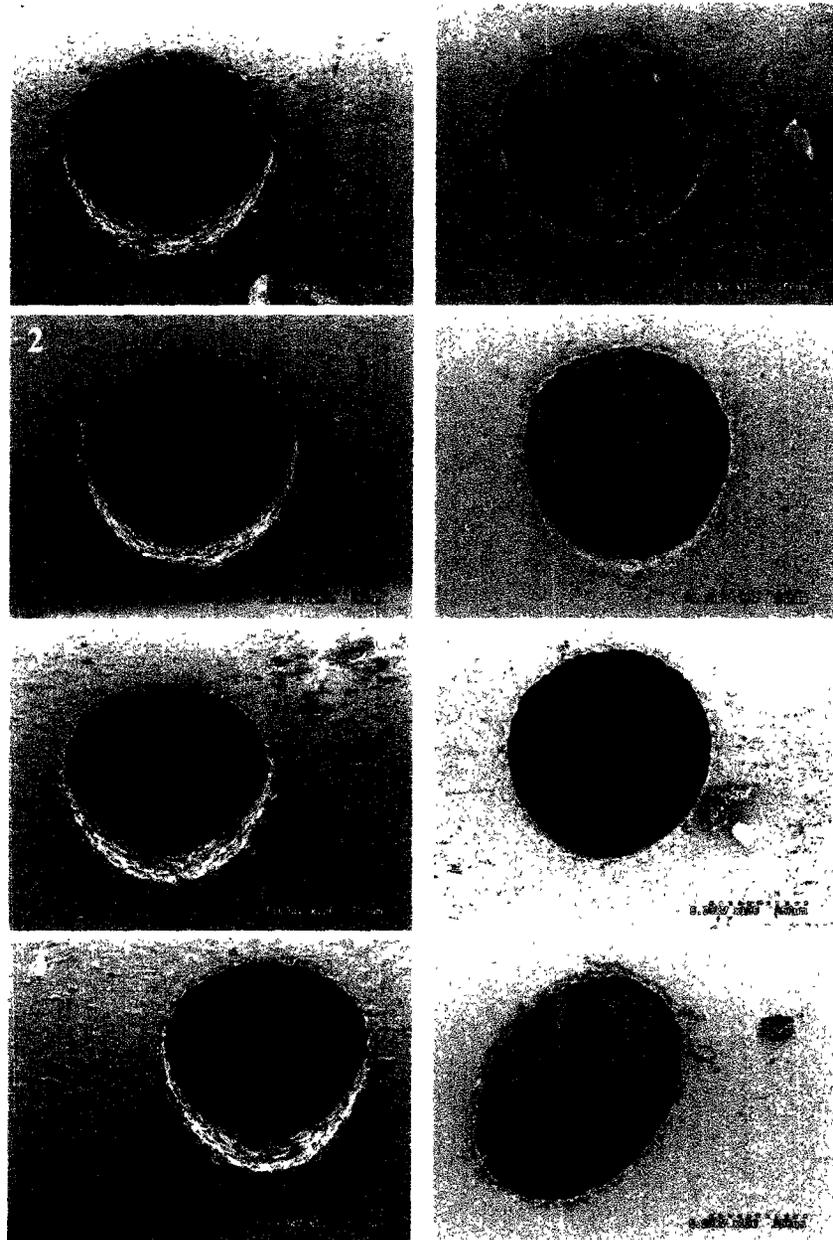
Figure 105. Series of images collected from Hitachi S3500N variable pressure scanning electron microscope of the inner surfaces of the tubing within the pods on the **reprocessed Octopus3[®] MT-104-3** following cutting. The images show irregularities on inner surface structure of the tubing (e.g. in all pod regions to varying degrees). There is debris, bioburden and irregularities present in the orifices of the tubing (e.g. in #1, #3, #5, #6, #7 and #8). The orifices are not as uniform in shape when compared to the “new” Octopus 3[®]. The numbers indicate the pod # (see Figure 5). This device has been imaged following staining for DNA. Scale bar in each image.

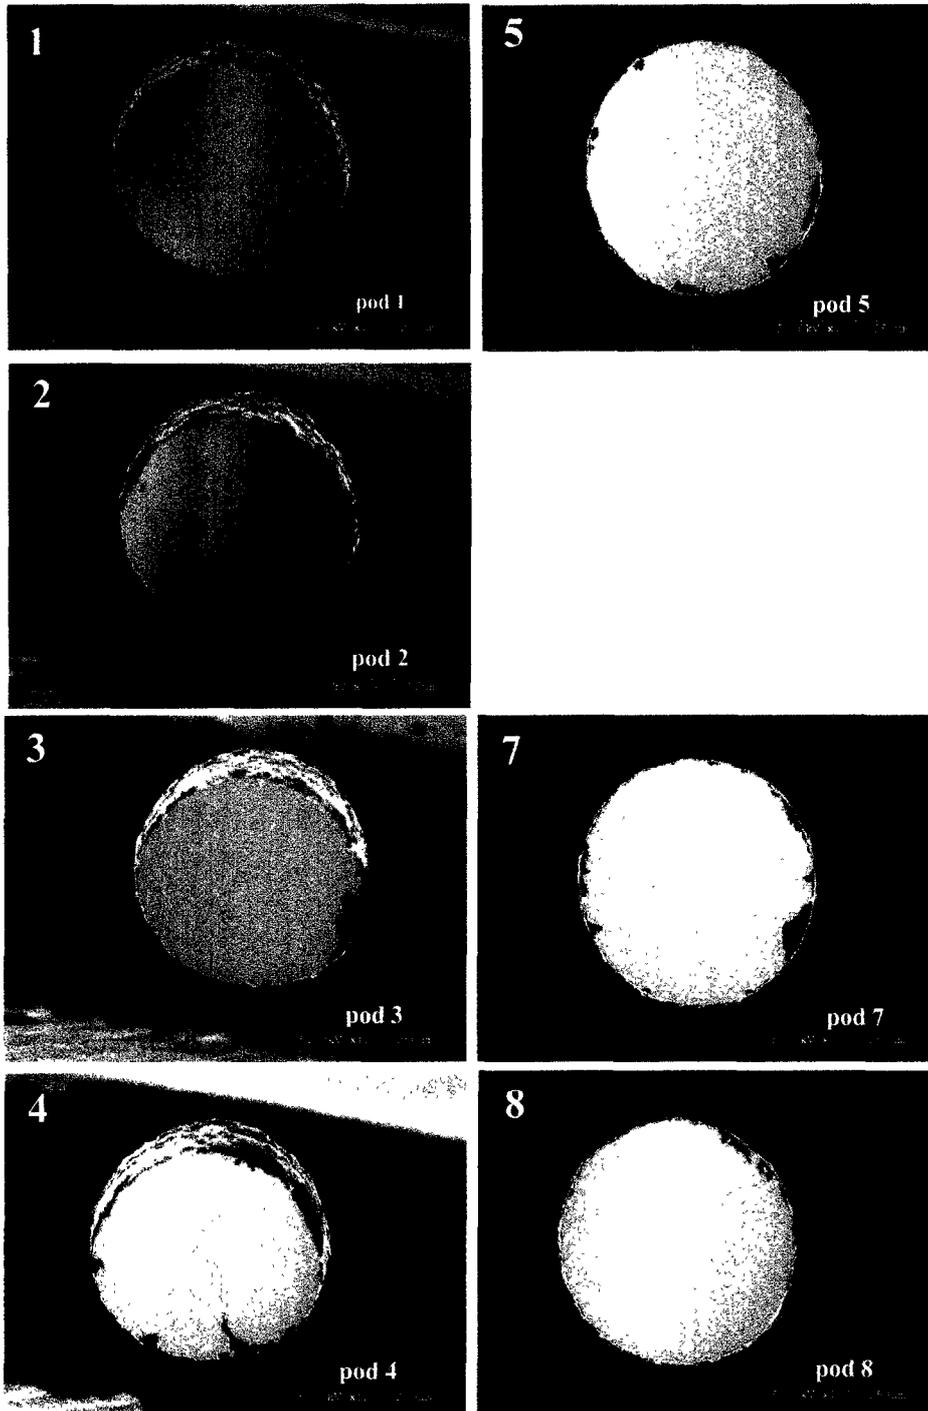
Figure 107. Series of images collected from Hitachi S3500N variable pressure scanning electron microscope of the inside surfaces of the tubing on the **new Octopus4[®] MT-104-2** following cutting. The images show uniform inner surface structure on the metal inner surface of the tubing. The openings appear to be uniform in size and composition. There are what appear to be small pieces of debris in some wells (e.g. #3, #7 and #8). The debris does not appear prior to disassembly and cutting of the device. The numbers indicate the pod # (see Figure 5). Scale bar in each image.

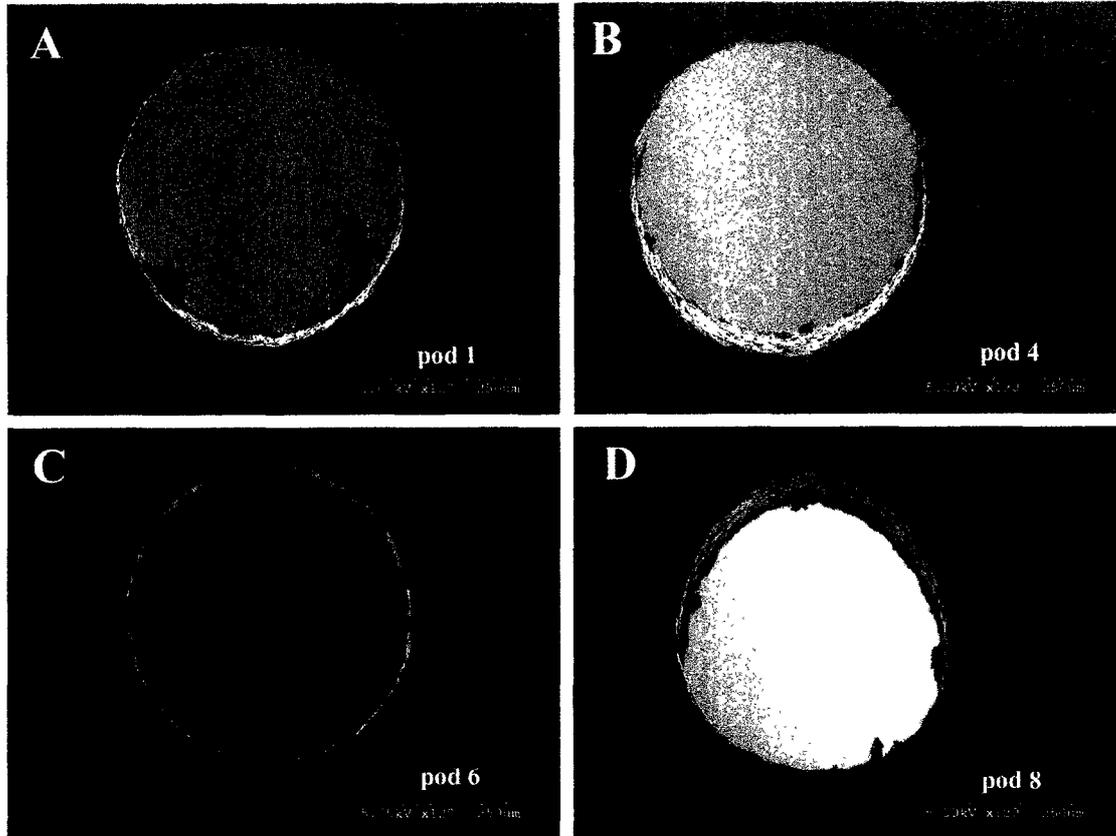
Figure 109. Series of images collected from Hitachi S3500N variable pressure scanning electron microscope in the areas of the orifices in the tubing within each pod on the **reprocessed Octopus4[®] MT-104-4**. The images show uniform surface structure on the metal surface of the tubing. The openings appear to be uniform in size and composition. There are what appear to be small pieces of debris in some wells (e.g. #3, #7 and #8). The debris does not appear organic. The numbers indicate the pod # (see Figure 5). Scale bar in each image.

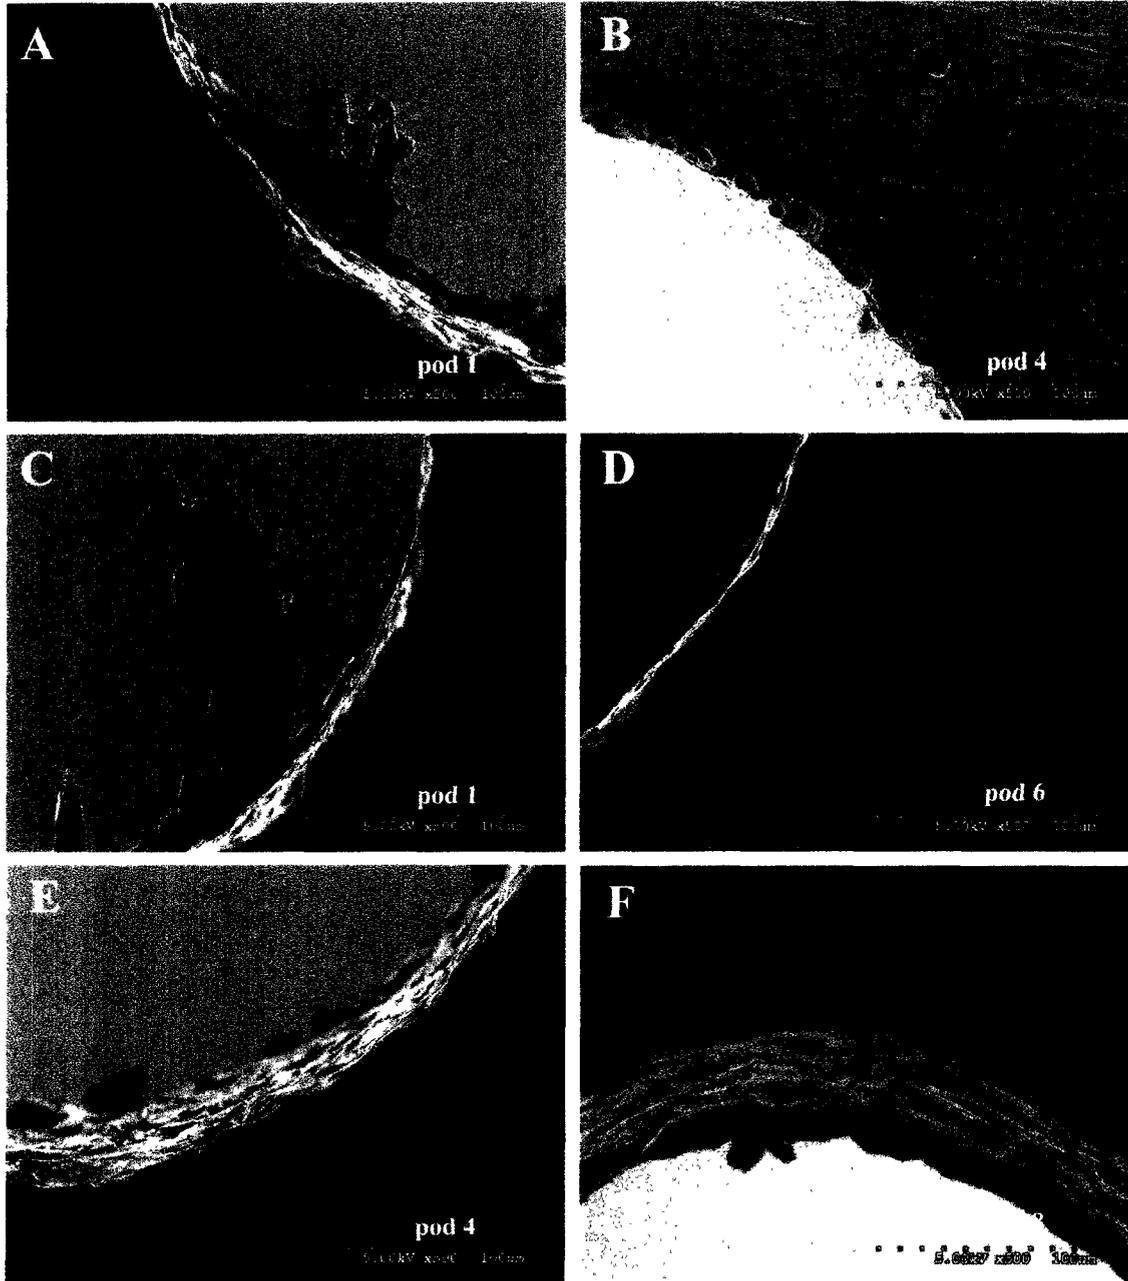
Figure 110. Series of images collected from Hitachi S3500N variable pressure scanning electron microscope in the areas of the orifices in the tubing within each pod on the **reprocessed Octopus4[®] MT-104-4**. The images show uniform surface structure on the metal surface of the tubing. The openings appear to be uniform in size and composition. There are what appear to be small pieces of debris in some wells (e.g. #3, #7 and #8). The debris does not appear organic. The numbers indicate the pod # (see Figure 5). Scale bar in each image.

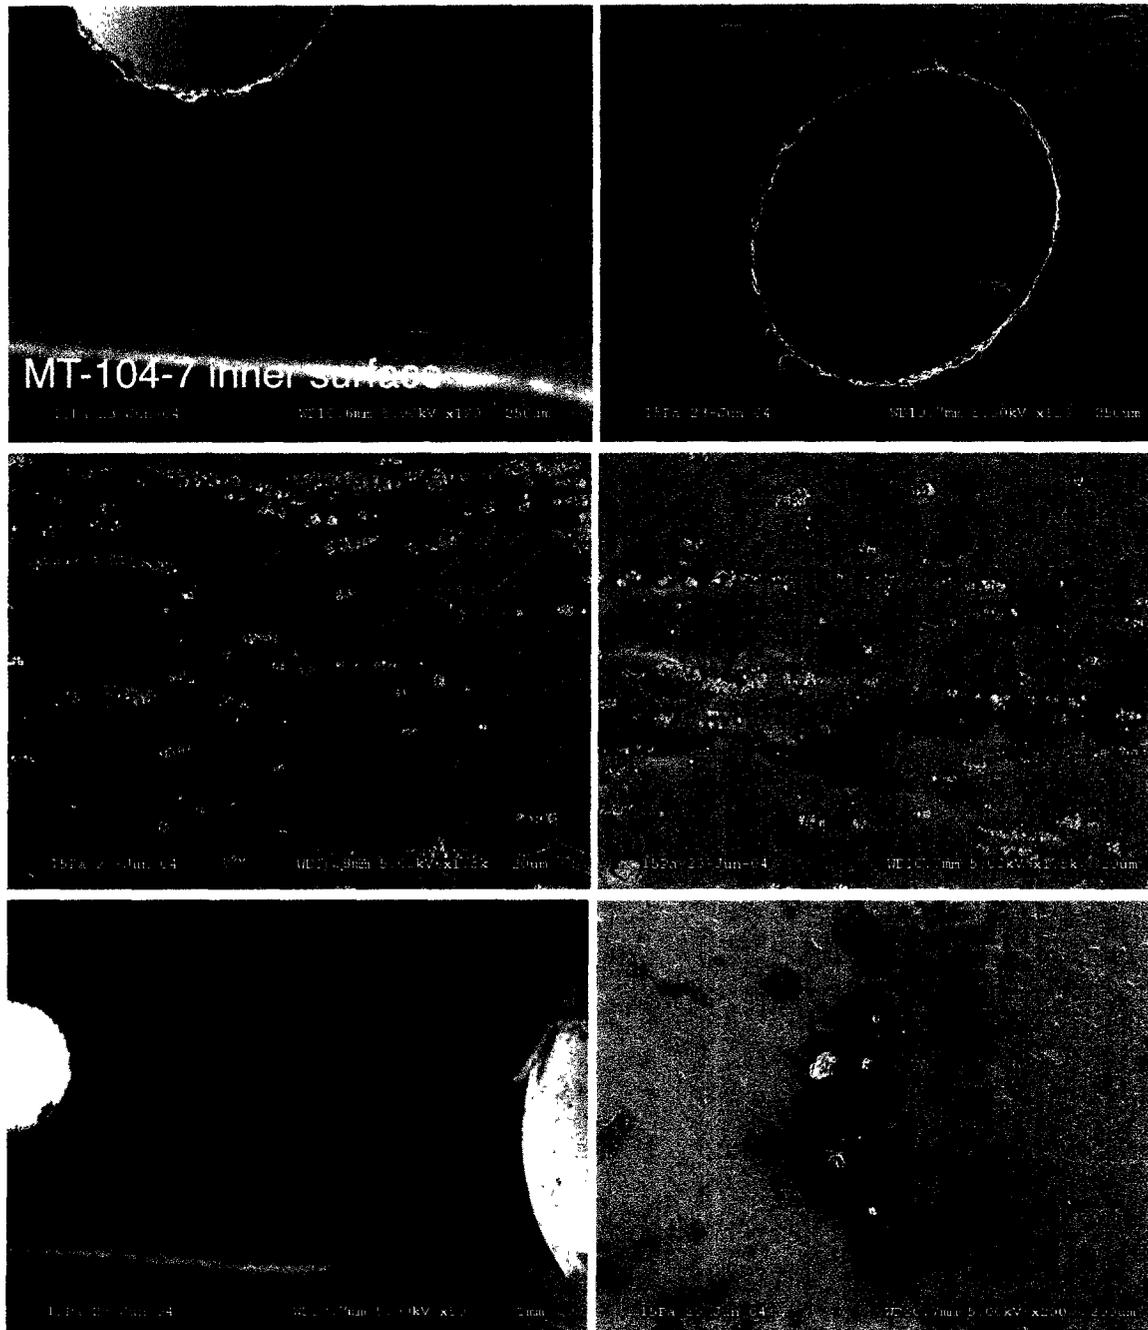
Figure 111. Series of images collected from Hitachi S3500N variable pressure scanning electron microscope in areas inside the hypotubing on the **reprocessed Octopus3[®] MT-104-7**. The images show irregularities and contamination to varying degrees on inner surface structure of the tubing in various regions. Bioburden and debris is present on the inner surface and in the orifices of the tubing. Scale bar in each image.

Pod 2 – irregular shaped hypotube opening
Pod 8 – irregular shaped hypotube opening
